TECHNICAL PROGRESS REPORT

Bell Report No. 60007-034

Quarterly Report

JPL Contract No. 951492

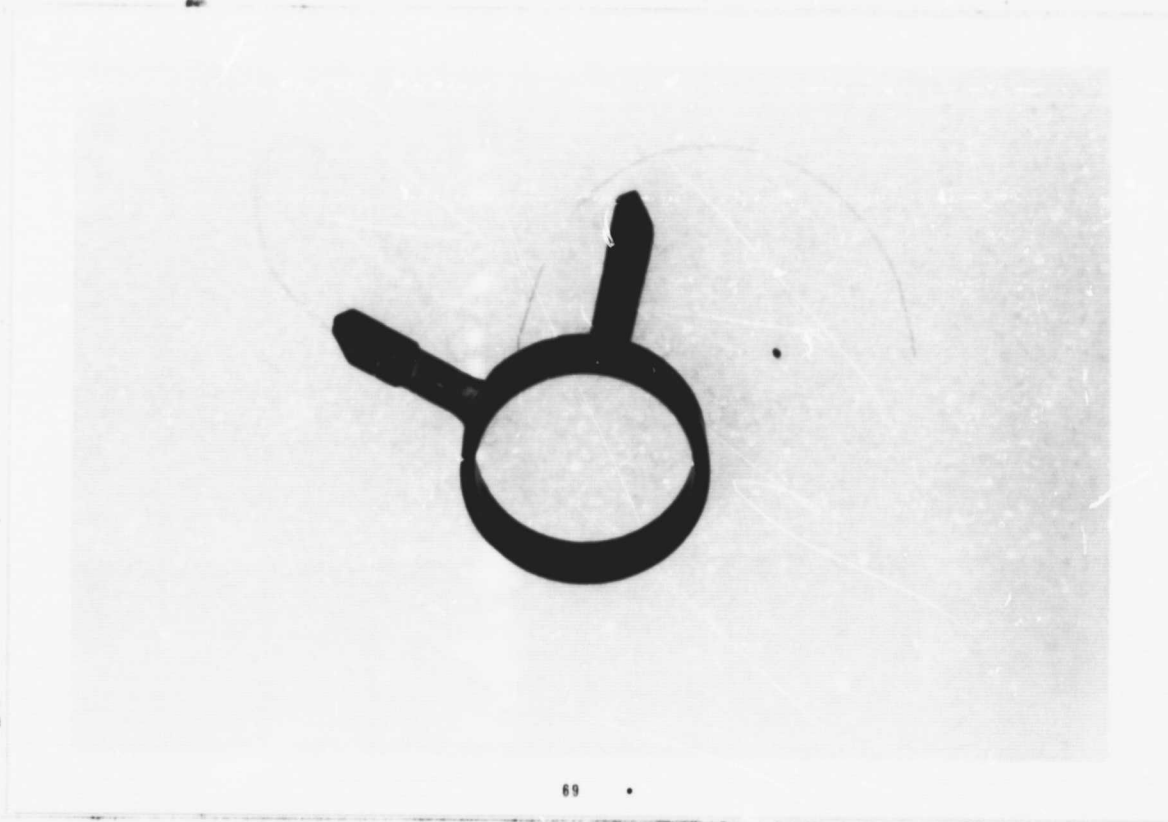
FIGURE 1. OUTER-WOUND BERYLLIUM
PROOFMASS STRUCTURE

In an effort to eliminate the thermal incompatibility between the aluminum pendulum and the steel base plate, the torque coil assembly of the fifth accelerometer is being built with the beryllium proofmass structure shown in Figure 1 and 2. The spring joint stresses should thereby be reduced by a factor of 40. Also to be incorporated in the fifth sterilizable accelerometer are "overaged" springs. In the standard spring manufacturing process, the maximum tensile strength of the spring material is attained by aging at 650°F for 30 minutes. Recently however, metallurgists from the Brush Beryllium Corporation have pointed out that the heat treating of the spring material for maximum tensile strength usually does not provide good form and dimensional stability.

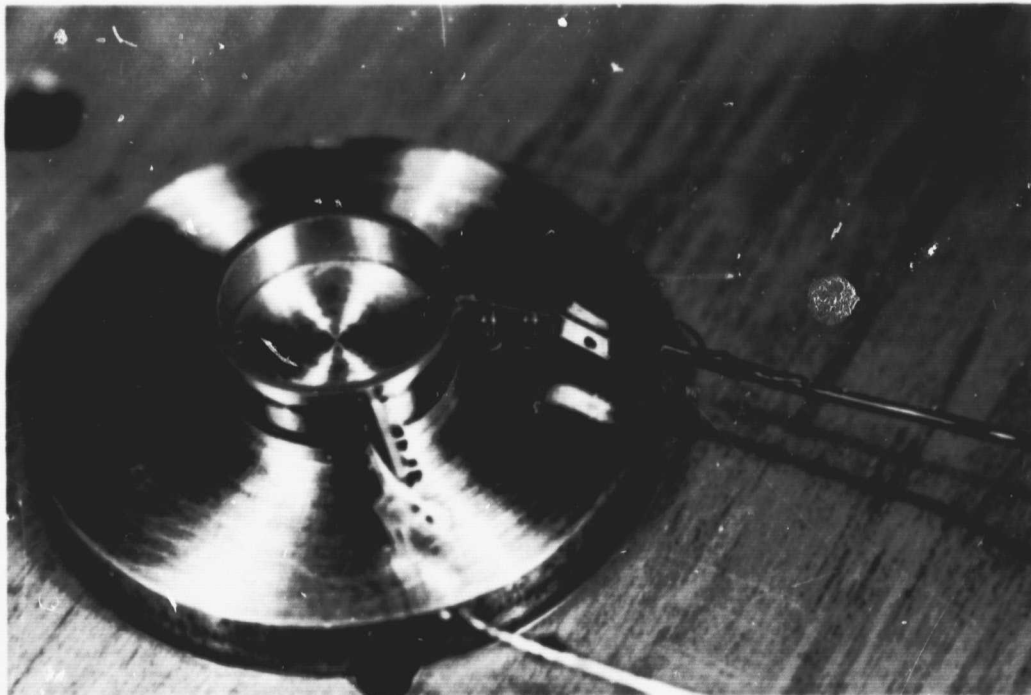
Figure 7. Aluminum Pendulum for
Laser Welding
